# Manhole Inspection Summary

Manhole # S21K\_\_050MH

Insp Date: **9/25/07 11:49 AM**

**Location** Address: **202 BRUCE ST**

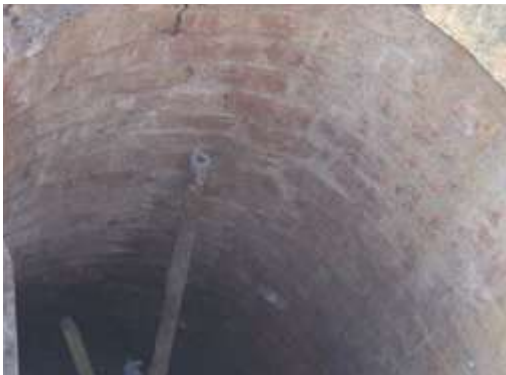
Defect 2

Infiltration: ☐ None ☐ Joint ☐ Cracks ☐ Mortar ☐ Roots ☒ **Wall**

CORBEL INFILTRATION

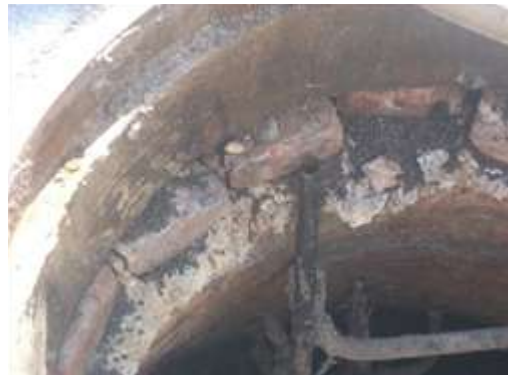
Defect 1

Offset: **3** (in.)

Condition: ☐ Sound ☐ Cracked ☐ Root Intrusion ☒ **Loose Brick** ☐ Deteriorated

FRAME OFFSET AND LOOSE BRICKS  
IN CHIMNEY

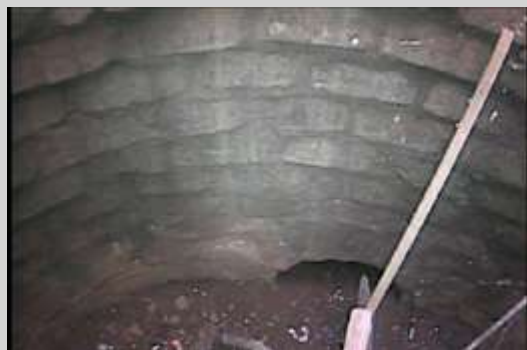
12 O'Clock Outflow

8 in. Circular Gravity Sewer  
Pipe Out @ 12 O'Clock

Deposits: ☐ None ☒ **Mud** ☐ Sludge ☐ Debris ☐ Grease

Silt Depth: **2** (in.) Deposits Extent: **Light**
